Executive Summary

This study was initiated by Neal Vogel of Restoric LLC to examine the finishes on the wood trim from the interior and windows of the Keokuk Train Station in Keokuk, IA to determine the original finishes. A total of four samples were provided to be examined; two from the baggage room, one from the freight room and an exterior window. In order to determine the original finishes, samples were extracted from the three sample boards provided which were examined under a stereo zoom microscope illuminated with a fiber optic ring light adjusted to daylight.

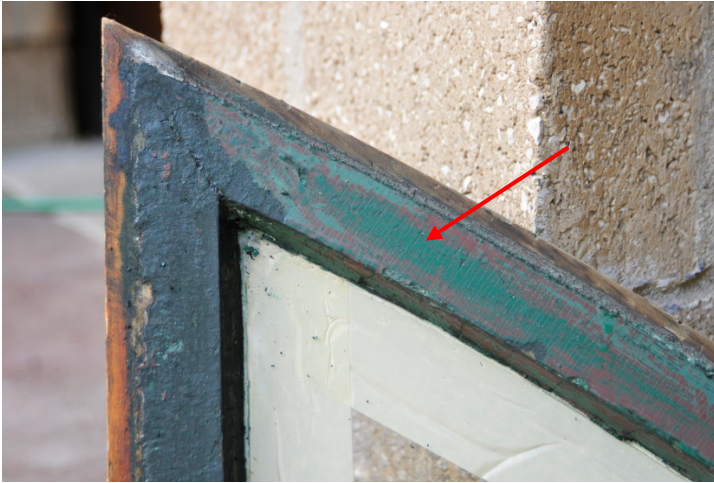
An entire window sash was provided to examine both the interior and exterior sides. Exposure windows were created on both sides of the window by carefully removing the overpaint layers in order to view the original paint surfaces. On the exterior face the earliest complete layer is a Green paint. This type of Green is a common exterior trim color used during the late nineteenth century. The original green was followed by a series of brown and green paint layers.

Figure 4: Detail Photo of the exterior side of the window sash. The exposure revealed a Green paint in the center of the wood section on the right as the earliest color (red arrow).

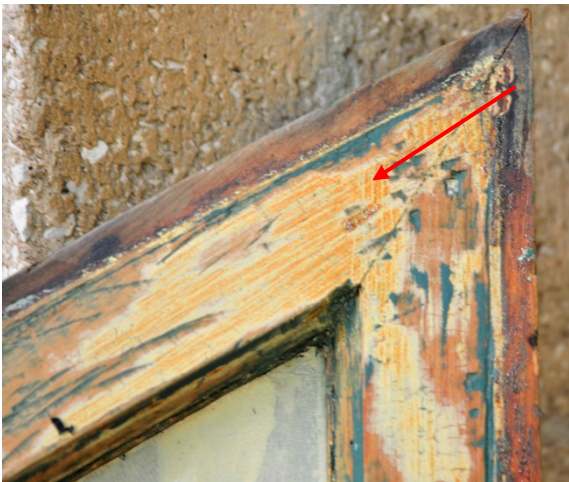
The exposure on the interior face revealed a painted faux wood grain finish. The graining is quite simply done to imply the look of wood, likely oak, rather than copy it. The glaze color used to produce the grain is Orangish Brown (Munsell 7.5YR 4/4 - 3/4) over an Off-White base color (Munsell 10YR 8/2 - 8/4). The glaze was likely applied and stuck off with a steel comb to produce the graining. It does not appear to have any additional manipulation of the glazing.

Figure 5: Detail Photo of the interior side of the window sash. The exposure revealed a painted faux wood grain finish of an Orangish Brown glaze over an Off-White base color (red arrow).
